NASA CR-188258

Final Report

THE MAGNITUDE OF IMPACT DAMAGE ON LDEF MATERIALS

Martha Allbrooks and Dale Atkinson  
POD Associates, Inc.  
2309 Renard Place, S.E.  
Suite 201  
Albuquerque, New Mexico 87106

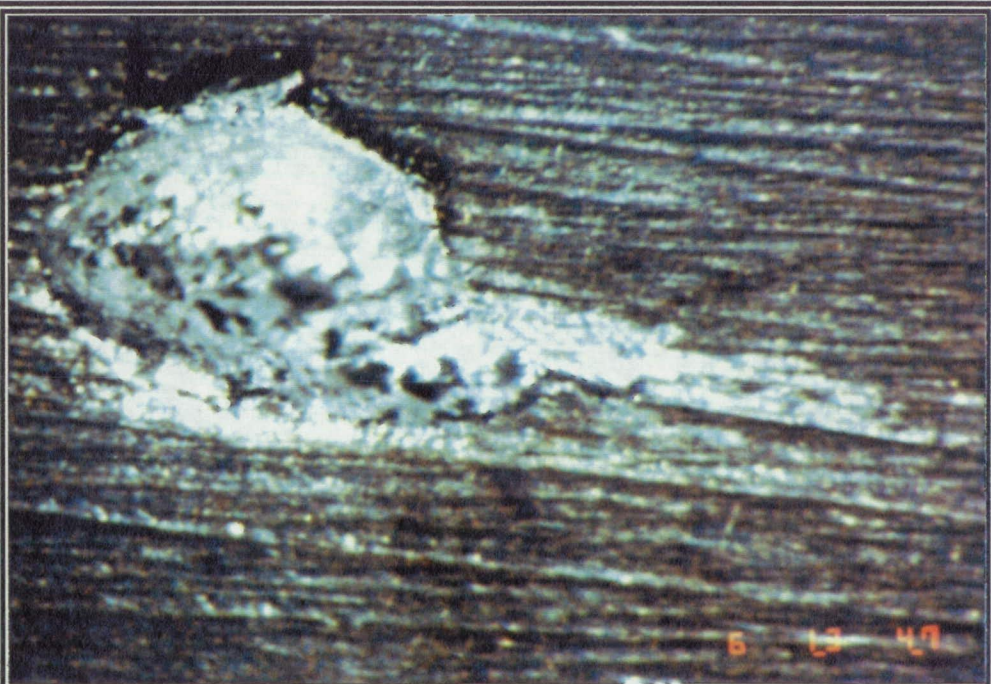
**Figure P2-4.** Photograph of an elliptical crater in aluminum resulting from an impact at a highly-oblique angle.

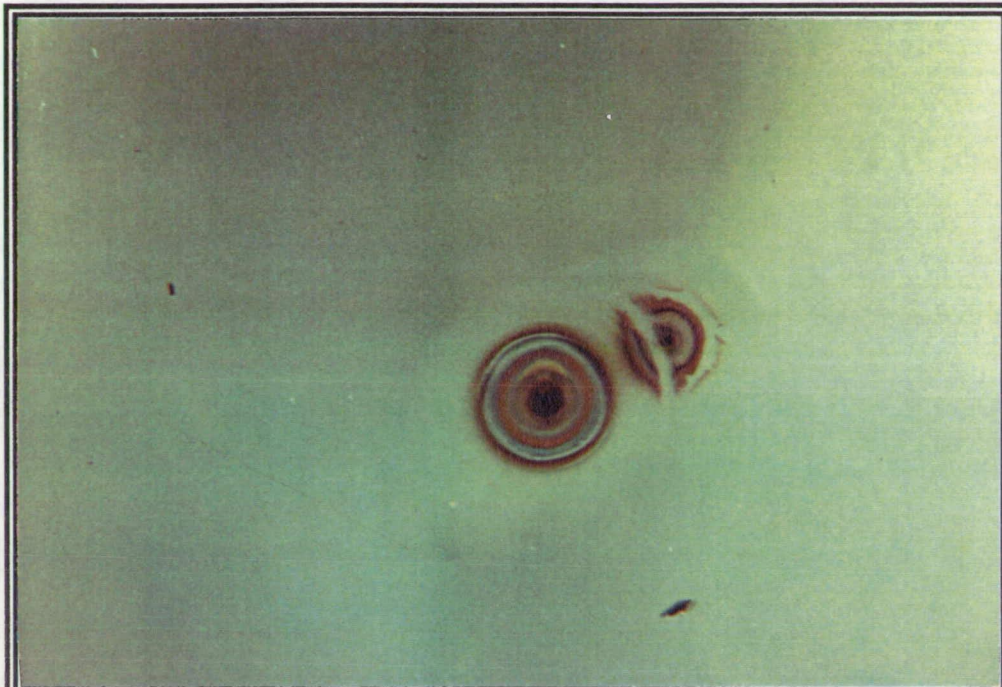
**Figure P2-22 (KSC-390C-2112.3)** shows two penetrations through an A0178 blanket from LDEF Bay C11. The delamination zone connects the two penetrations. These two events were separated in time but the larger penetration (on the right) probably occurred after the smaller penetration. This disrupted the ring structure which was growing around the smaller penetration due to AO degradation of the silver, leaving the deformed pattern. This also shows the size of the delamination and shock wave caused by the larger impact. This total view measures ~9 cm across.

**Figure P2-22.** Photograph of two impact penetrations through a Scheldahl G411500 silvered-Teflon thermal control blanket.

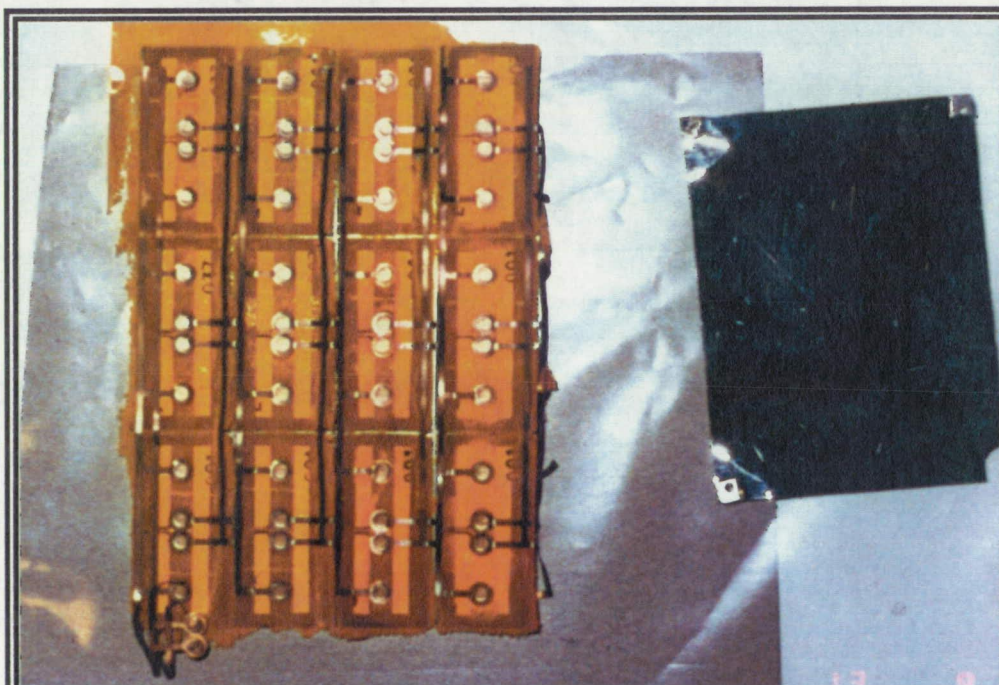
**Figure P2-46.** Photograph of a portion of a solar panel from the A0171 experiment from Bay A08.
